Managing complications when the prerequisites for an implant-supported restoration are not ideal: a case report

What to do if ... ?

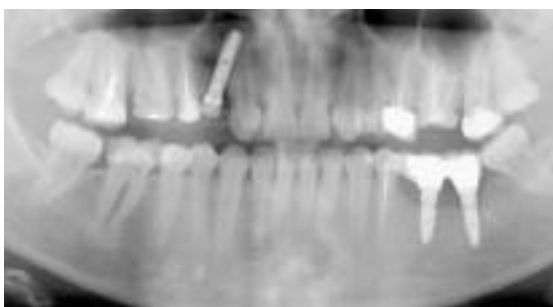
Fig. 1 Baseline panoramic radiograph: The implant overlaps the root apex of tooth 13.

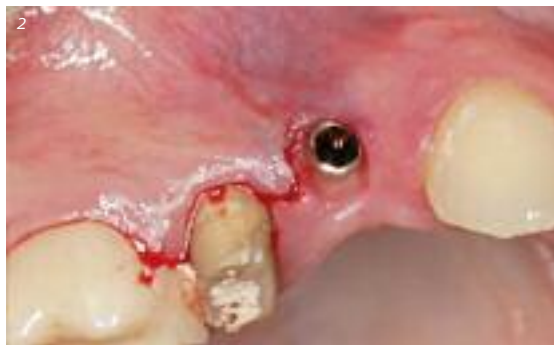
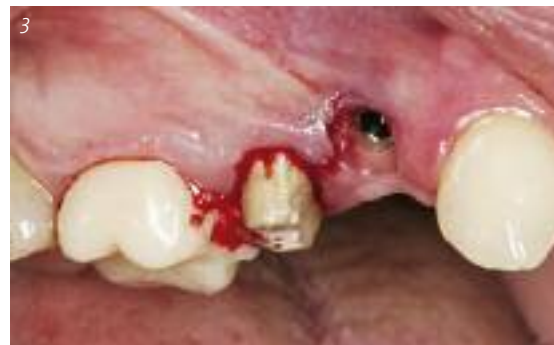
*Figs. 4 and 5
Split-thickness
flap without
relief incision
using the tun-
nelling tech-
nique.*

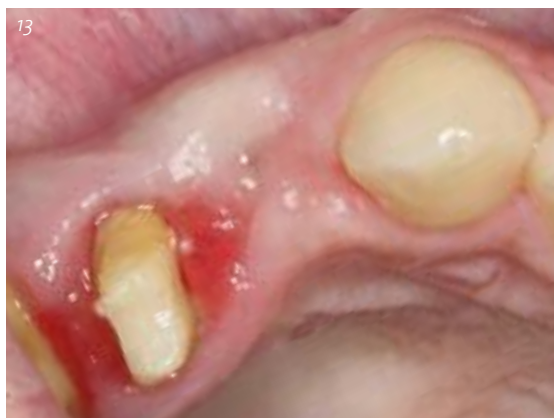
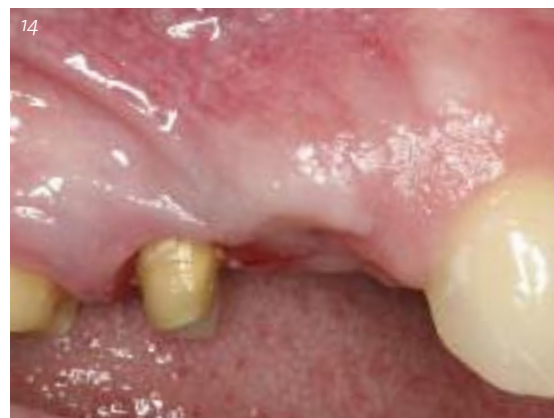
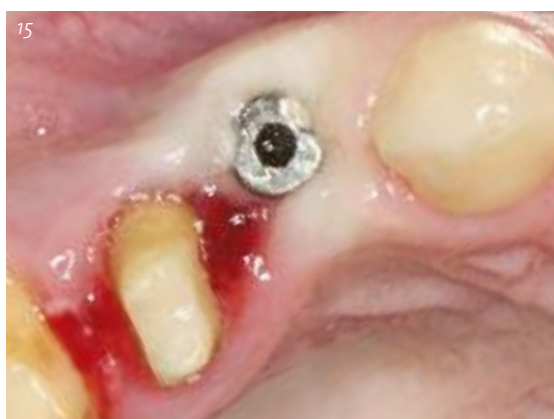
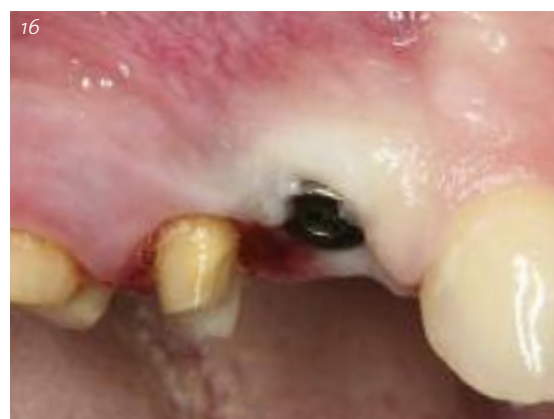
*Fig. 17
Provisionalization
of implant 14 and
teeth 15 and 16.*

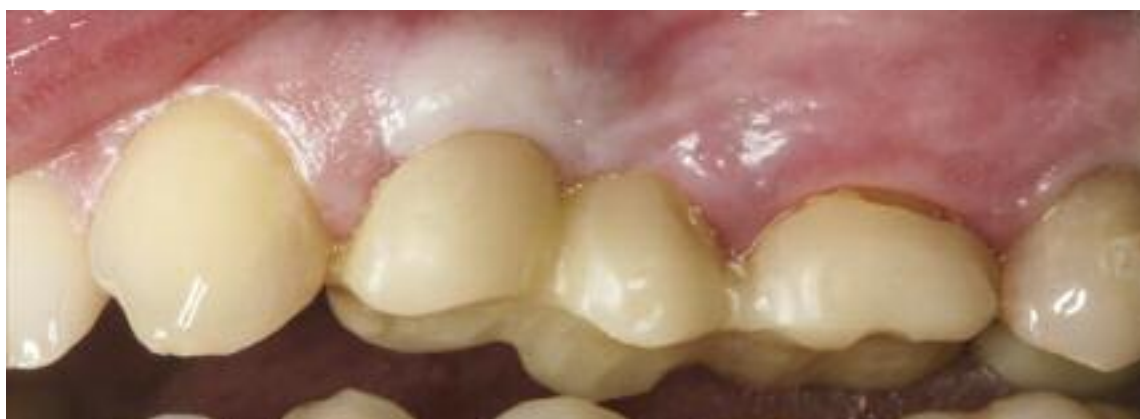
essary problems during suture removal. Interrupted sutures were placed in the regions of the interdental papillae for additional fixation following apical convergence of the flaps using mattress sutures. It is important to adapt the flap with as few sutures as possible and without creating tension (Figs. 9 and 10). Too many sutures, or sutures that are too strained, may cause tension, which in turn promotes tissue anaemia. Soft-tissue coverage of the implant was performed under magnification in a minimally invasive procedure following microsurgical principles. The tissues healed without tension (Fig. 11); the sutures were removed after two weeks (Fig. 12).

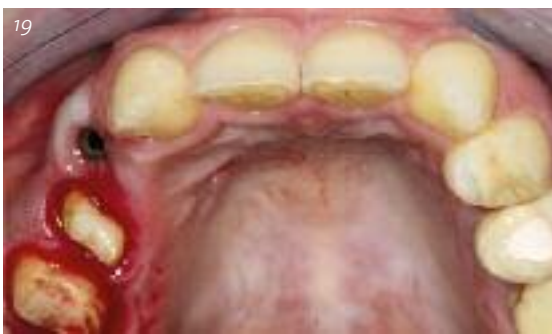
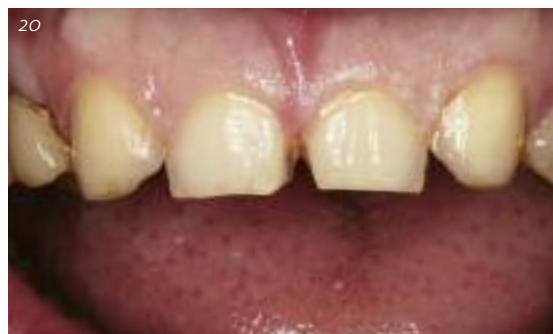
*Figs. 19 and 20
Teeth 15 and 16 were slightly reprepared, and teeth 13 to 23 were prepared for veneers.*

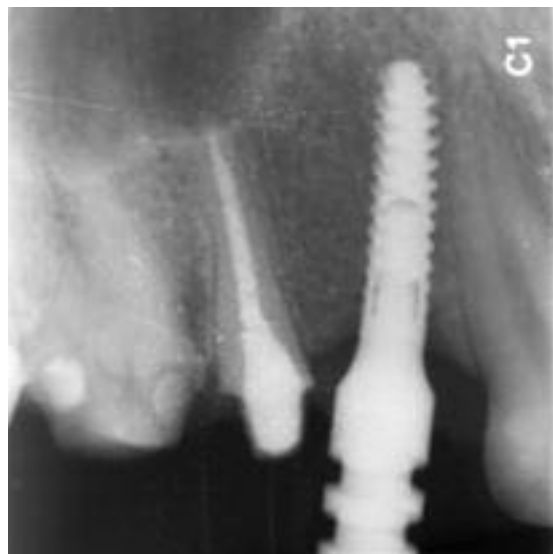
*Fig. 21
Radiograph with an impression post seated on implant 14. The radiograph shows that tooth 13 was not damaged during insertion of the implant.*
